22 November 2010

Your ref: B1030964
Our ref: 2898

13 Holland Street, Cambridge, CB4 3DL

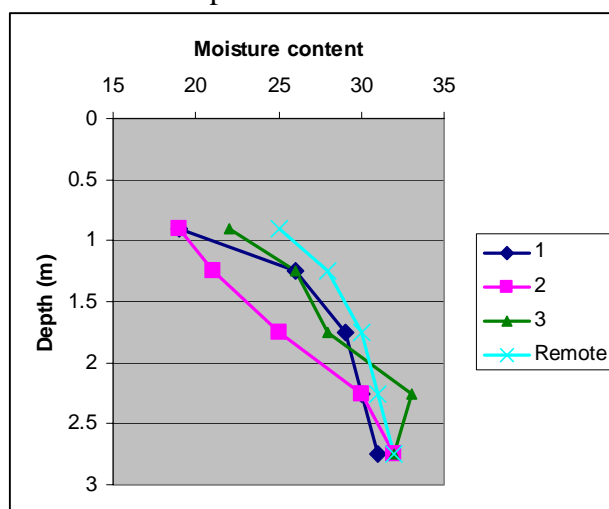
2. I find the soil investigations to be of very limited value. For ease of interpretation I show the moisture content profiles from the 4 boreholes in the graph below. The moisture content in

borehole 2 is slightly below the other boreholes, with boreholes 1 and 3 only marginally drier than the remote hole. Possible desiccation in borehole 2 is corroborated by the elevated soil suction values between 1.0 and 2.0m. Suction values in the other boreholes show no evidence of desiccation. I understand that borehole 2 is on the rear corner of the house, and thus apparently in one of the areas of damage. The evidence of slight desiccation in this borehole is thus consistent with the trees as a cause of damage. The absence of evidence of desiccation in the other holes probably reflects the time of year of these investigations.

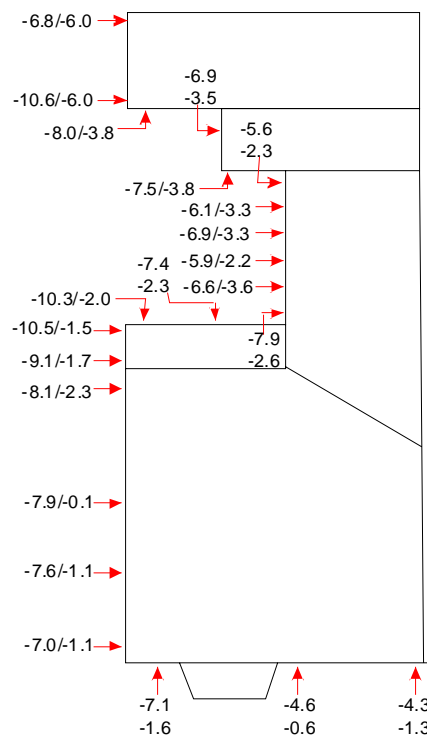
5. The plan below, derived from the Geoserv plan, shows the location of the levelling markers, and the amount of seasonal subsidence recorded in summer 2008 (first set of numbers) and summer 2009 (second set).

6. It is apparent from this that there was significant movement in summer 2008, particularly along the flank wall of the main house and front of the garage. Movements diminish progressively across the front elevation, and are reduced along the front elevation of rear section of the building. This distribution of movement is clearly consistent with the involvement of the plane trees as the cause of damage.

7. This distribution of movement, combined with the evidence of probable desiccation in borehole 2 and the presence of plane roots, confirms that the trees were the cause of the damage. The extent of movement, which was well in excess of 5mm on the parts closest to the trees, was sufficient to account for the damage.

8. The level monitoring is of even greater value in demonstrating the effect of the crown reduction in March 2009. It is clear that the movements in summer 2009 were considerably less than in 2008. In part this might be explained by the readings on 17/08/09 not recording the full extent of seasonal subsidence for that year. However, the summer of 2009 was generally drier than 2008 and therefore in most situations one should expect movements in 2009 to have been significantly greater. I therefore consider that the reduced movement in 2009 is highly significant and should be attributed to the reduction of the trees in the spring of that year.

12. Even if they were reduced to an acceptable level in 2010, further pruning would be required during this winter to reduce the amount of regrowth. However, it is my opinion that significantly heavier crown reduction should be applied. I would doubt whether the 30% reduction applied in March 2009 would have been sufficient.

16. If the trees are reduced it will be essential for the level monitoring to be continued to confirm the efficacy of the treatment. This should involve a further set of readings in April or early May (to check the full extent of recovery), and then further readings in late June, early August and mid-September. If the readings in June or August show unacceptable movements beginning to occur, further action could be taken immediately to stop any further development. However, I consider the risk of this to be very remote. Further reading in September 2012 can confirm that movements have not re-commenced.
